# Manhole Inspection Summary

Manhole # S31EE\_030MH

Insp Date: **8/25/08 12:36 PM**

**Location** Address: **259 LANVALE ST**

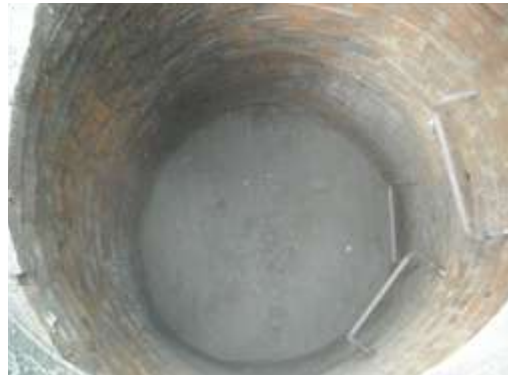
Top View

☒ **Debris** (not Condition related)

Channel debris.

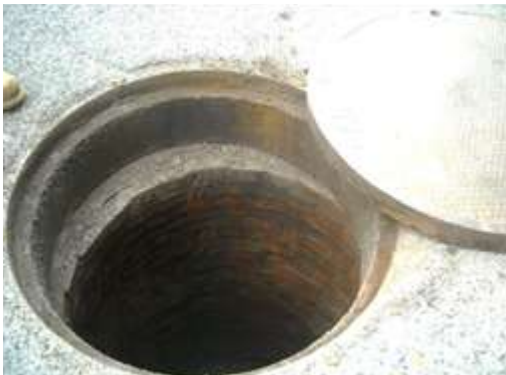
Defect

☒ **Leaks**

☒ **Joint**

☒ **Mortar**

☒ **Wall**

Frame leaks. Corbel and Barrel infiltration.

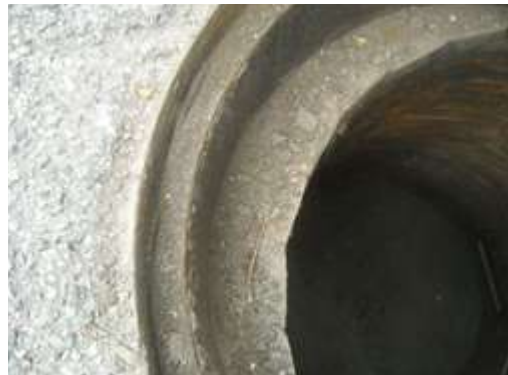
Defect

Offset: **3** (in.)

Frame leaks. Frame offset. Corbel infiltration.

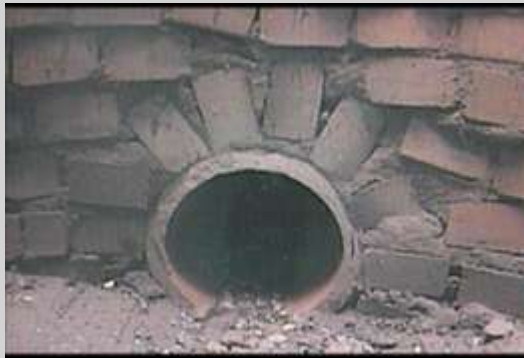
8 in. Circular Gravity Sewer  
Pipe Out @ 12 O'Clock

☒ **Deteriorated**

Barrel deterioration and infiltration.
